U.S. DEPARTMENT OF COMMERCE
National Oceanic and Atmospheric Admin.
NATIONAL OCEAN SERVICE
Damage Assessment Center
Florida Keys National Marine Sanctuary

SUBJECT: *D Man I* vessel grounding assessment report

FMP INCIDENT (CASE) #: 01-3A-11456

NAME & DESCRIPTION OF VESSEL: *D Man I*, 34' 1986 Sea Ray Model 340EC

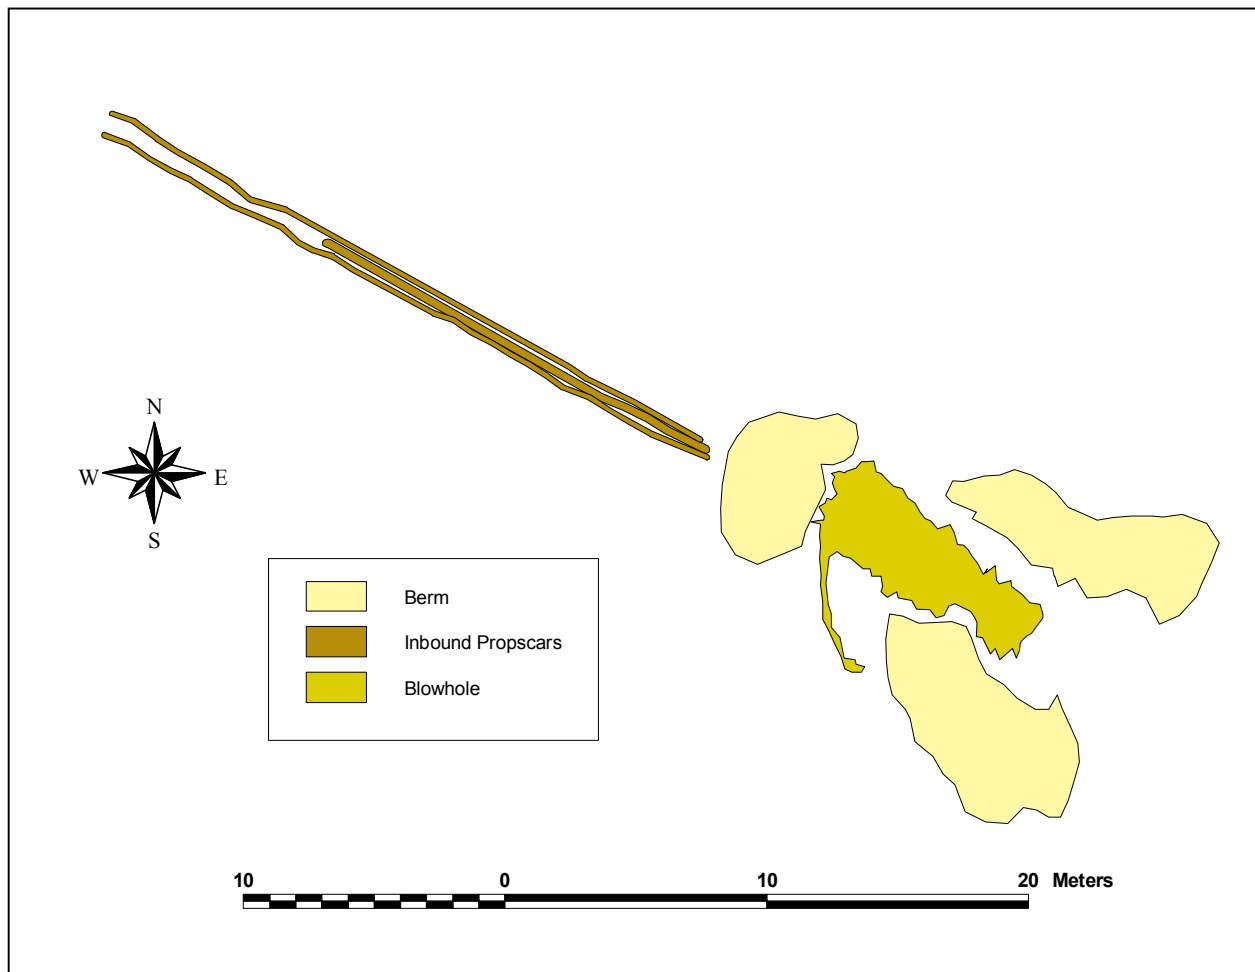
The injury consisted of a blowhole, three berms and an inbound track (see Figure 3). The blowhole had a planimetric area of 27.00 m² with a maximum depth of 0.7 meters below the surrounding seafloor (see Figure 4). The volume of material removed is calculated to be 7.60 m³ with a baseline of 0.1 meter below water level. The material excavated from the

Figure 3. Physical dimensions of *D Man I* injury.

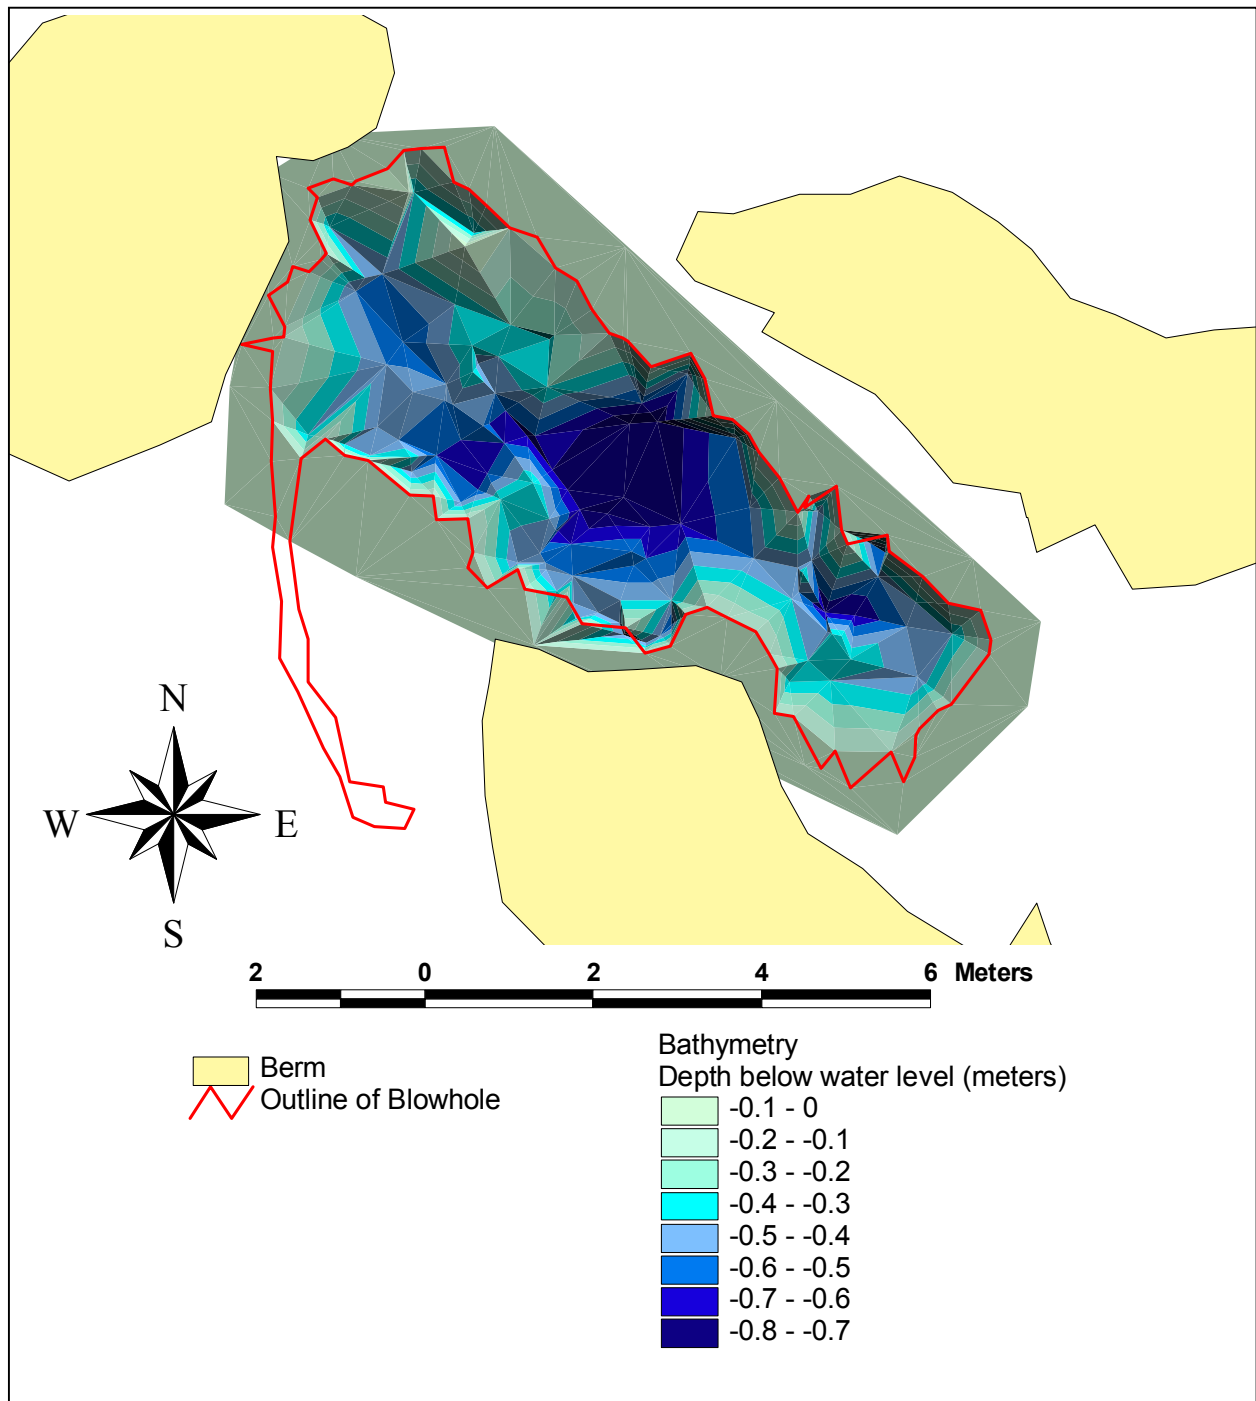
Figure 4. Bathymetry of the *D Man I* blowhole (base depth is -0.1 meters below water level).

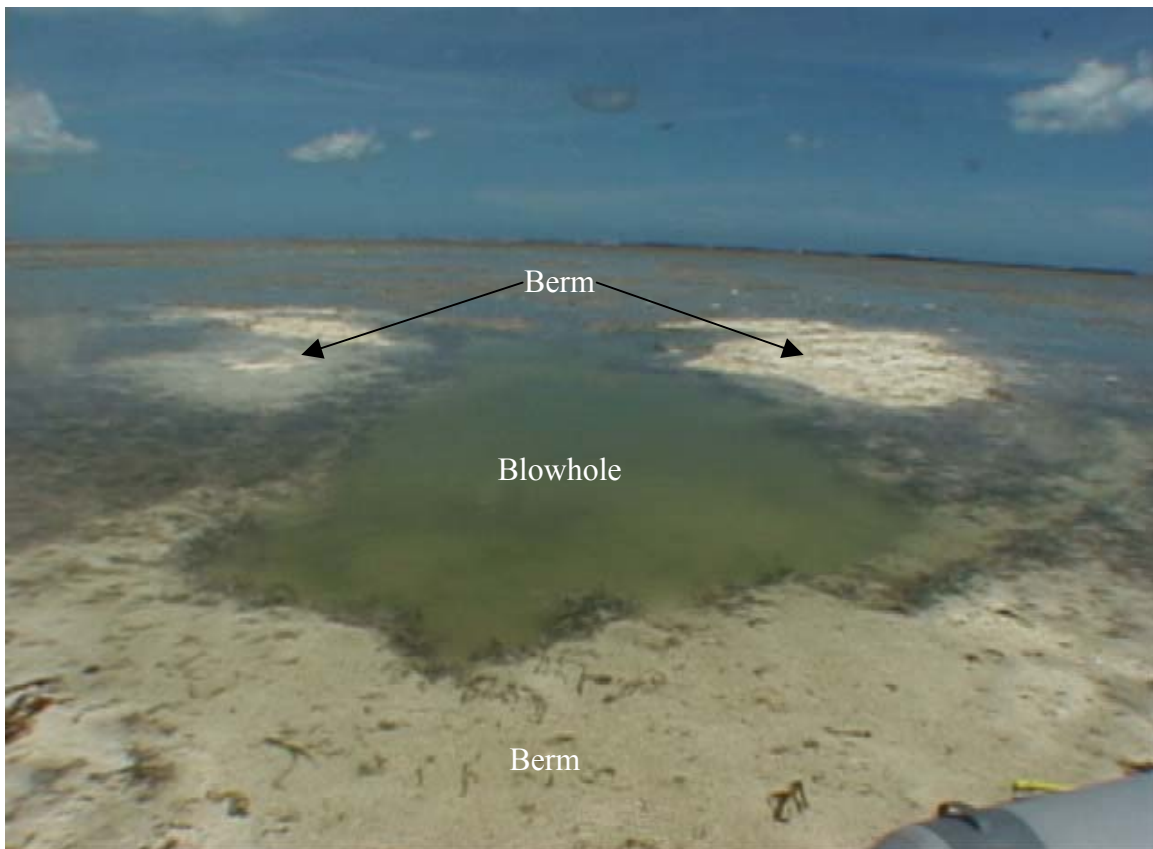
blowhole created three berms (see Figure 5).

The northwest berm, between the blowhole and the inbound track, covered an area of 20.36 m² of seagrass bottom cover. The northeast berm and the south berm covered area of 27.94 m² and 34.28 m² respectively.

Figure 5. Photo of *D Man I* blowhole and berms. Photo taken from end of the inbound track.

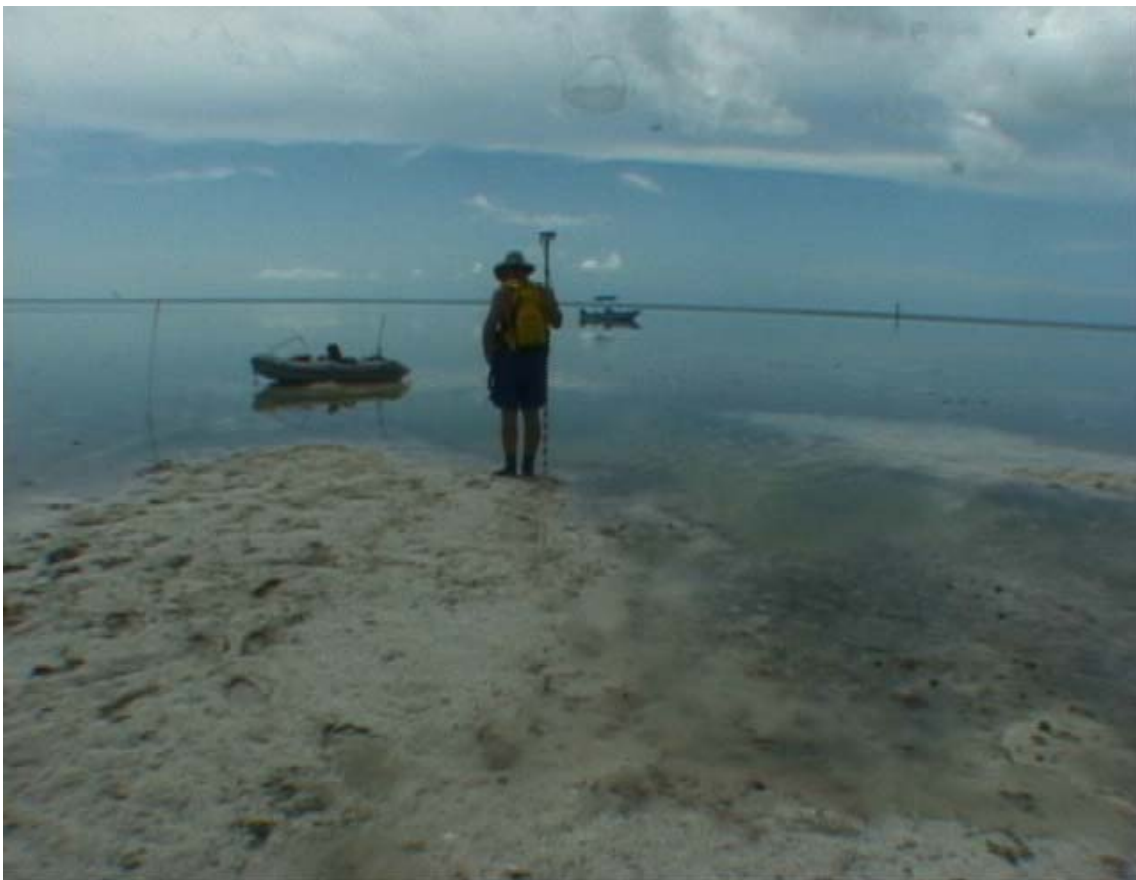
At low tide portions of both the northeast and south berms were exposed (see Figure 6). The inbound track, proceeding at a bearing of 118° toward the blowhole, consisted of two propscars and a keel scar (see Table 1). The total area of seagrass bottom cover damaged as a result of the inbound track is 15.37 m².

Figure 6. Photo of *D Man I* injury at low tide with berm exposed above water level.
